A Report on Determining the Bond Strength Developed
Between Grout and the Inner Wall of Hollow Concrete Blocks

February 1957

State of California
Department of Public Works
Division of Highways
Materials and Research Department

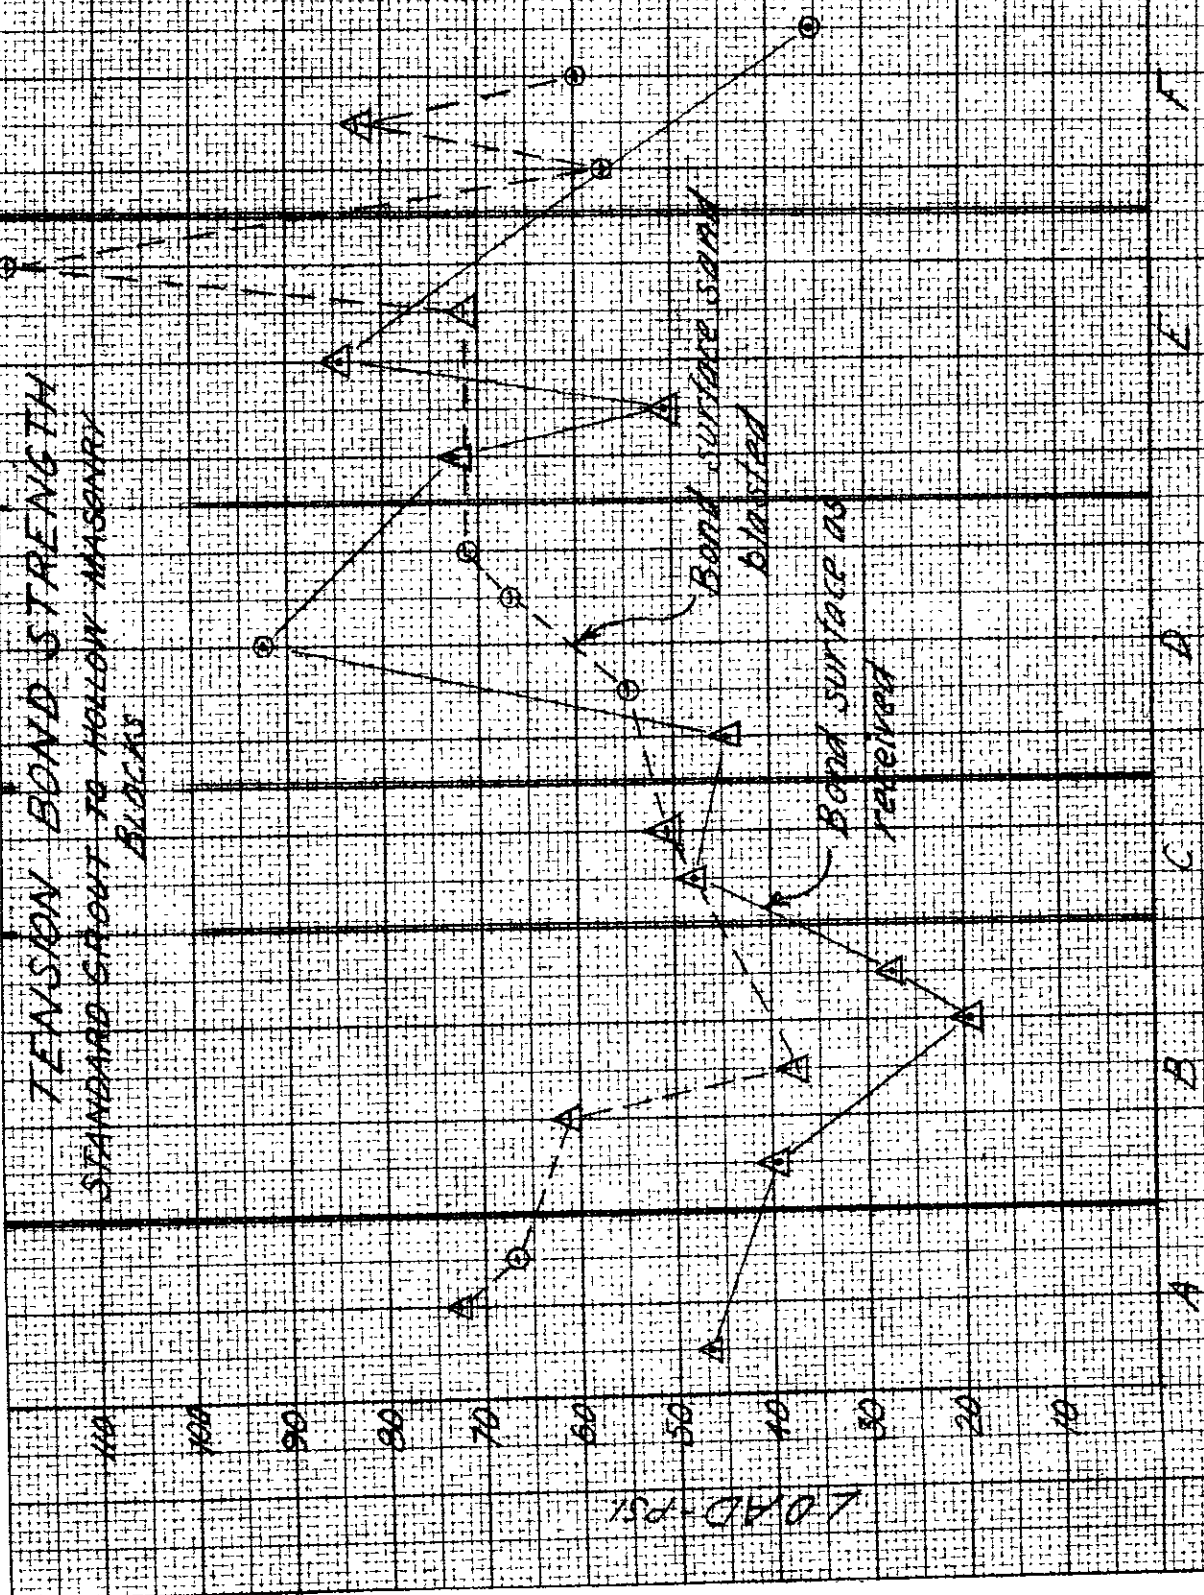
TENSION BOND STRENGTH

STANDARD GROUT TO HOLLOW MASONRY BLOCKS

Note: Δ Band Failed

○ Block Failed

Band failed on three blocks during sawing operation

The results of the tests are plotted by groups in Exhibit I and are tabulated on Exhibit II.
